HIGHWAY RESEARCH REPORT

DYNAMIC TESTS OF WOOD POST AND TIMBER POLE SIGN SUPPORTS SERIES XV

NO. M & R 636398

Prepared in Cooperation with the U.S. Department of Transportation, Bureau of Public Roads December, 1967

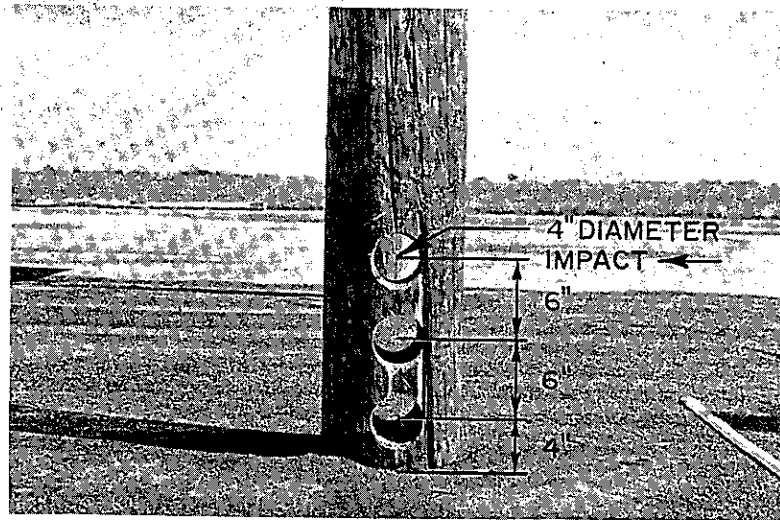
FIGURE 2

To produce this weakened plane, three 4" diameter holes were bored horizontally through the neutral axis of the Class 2 timber pole parallel to the sign face as detailed in Figure 2.

Theoretical calculations indicated that this 45.4% reduction in cross sectional area would significantly reduce the shear capacity of the pole without materially

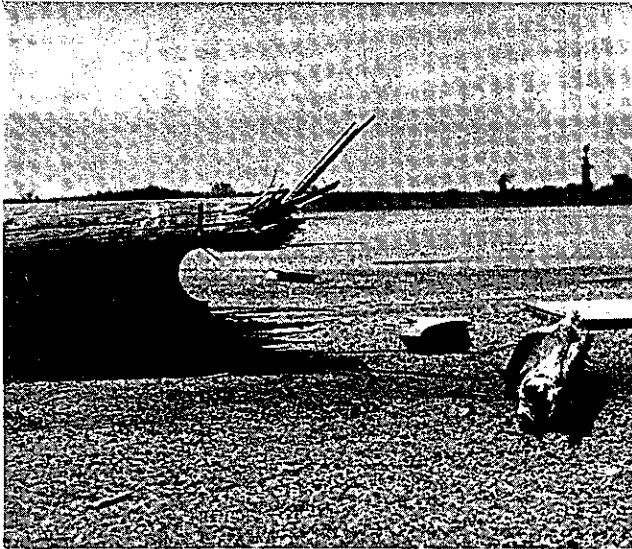
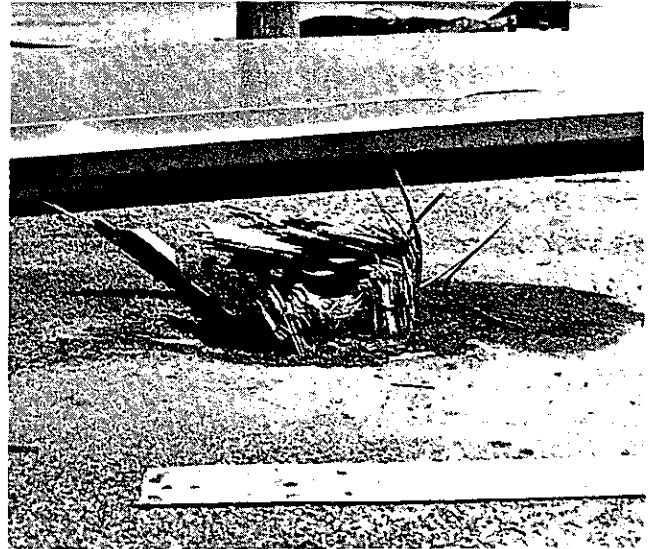
FIGURE 3

The results of the impact test indicated that this modification was effective in reducing the impact severity. However, analysis of the high speed data film of the impact and evaluation of the appearance of the fractured pole revealed that the type of failure which occurred in the pole was not what had been anticipated.

Prior to this test it was felt that failure would result primarily from excessive shear stress and produce a clean break through one of the weakened planes where the cross sectional area had been reduced. However, the high speed data film revealed that a beam type failure occurred with the wood material splitting between the holes, thus allowing vertical slippage. This let the two sides of the pole break independently of one another. Sequence pictures illustrating this failure are shown in Plate A, Test No. 153, of the Appendix. The appearance of the broken pole after impact is shown in Figure 3.

Although failure was not necessarily the result of excessive shear stress, this test did prove that this particular pole modification was effective in reducing the safety hazard presented by a Class 2 pole.

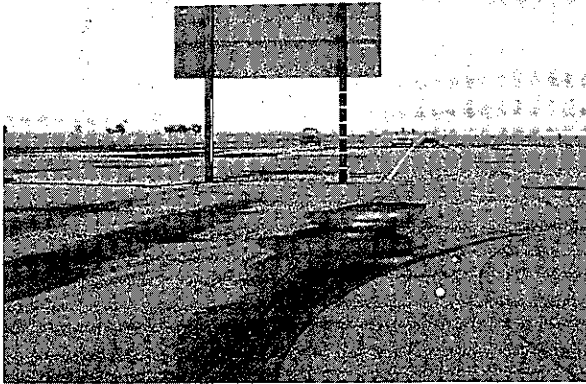
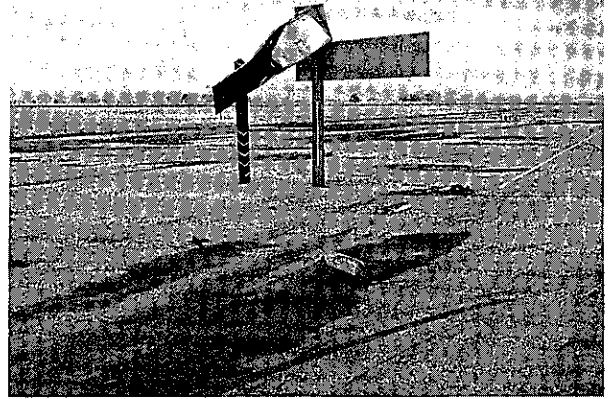
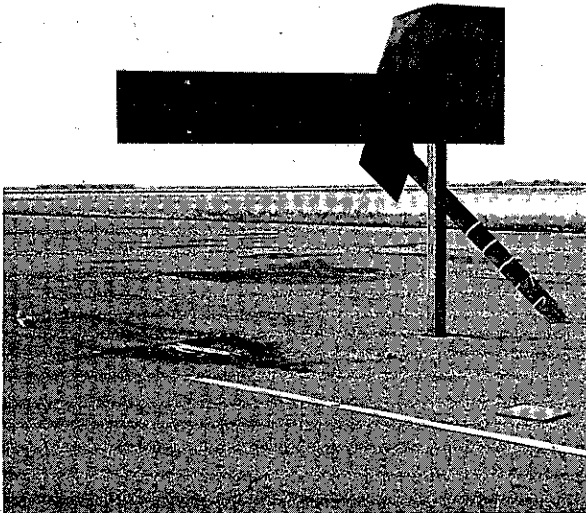
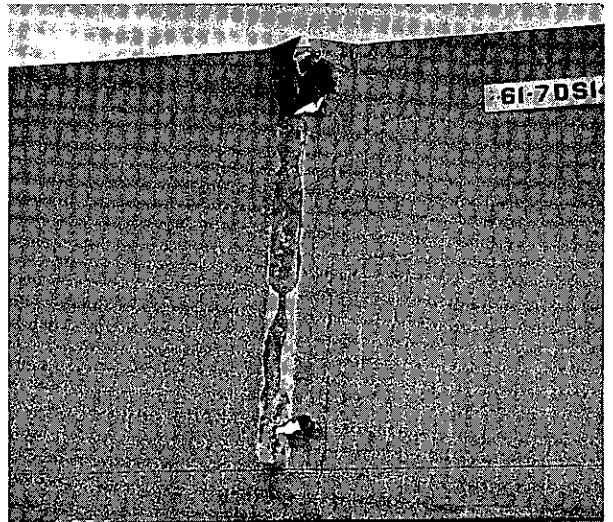
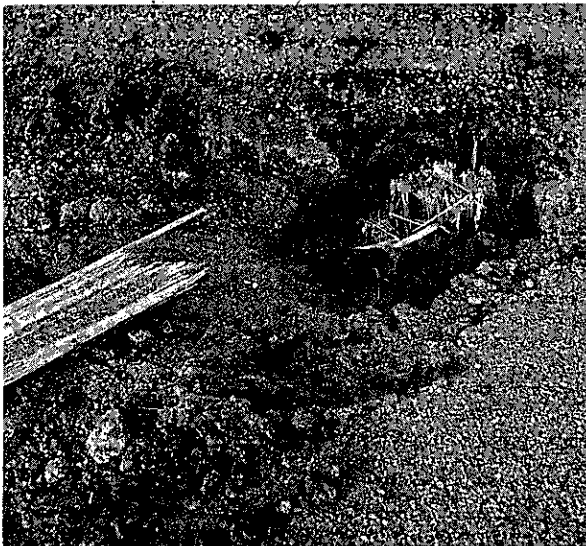
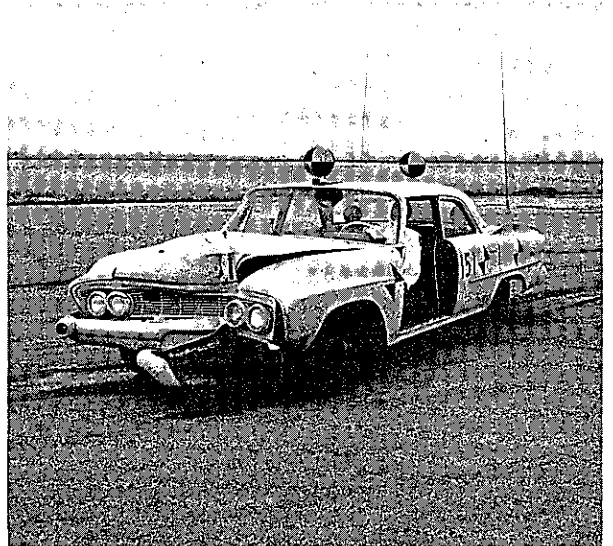
TEST 151 PLATE C

The impacted post sheared at ground level and was propelled upward and to the right by the force of impact. The pole tore loose from the lower panel, pulling the mounting bolts through the sign panel, but remained attached to the upper panel which it twisted and bent as it swung in an arc down and to the right of the right support post. Neither sign panel could be salvaged.

The vehicle sustained moderate front end damage.

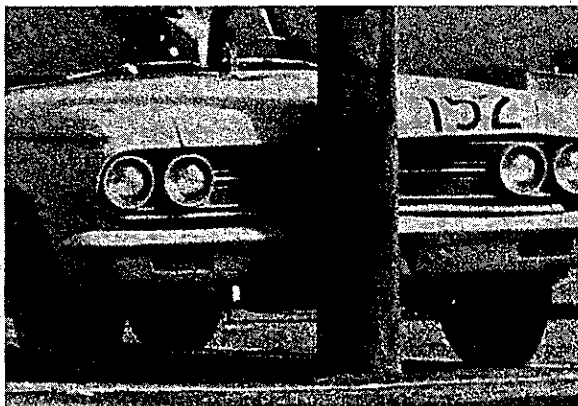
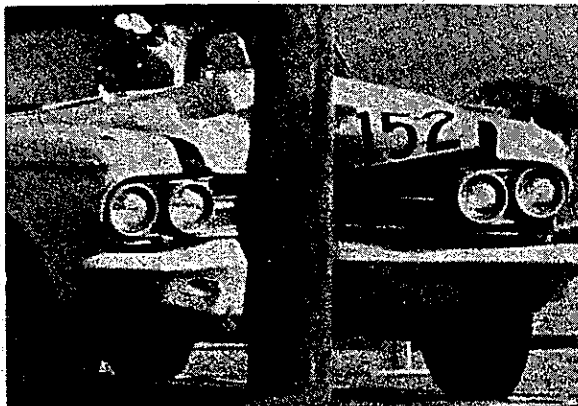
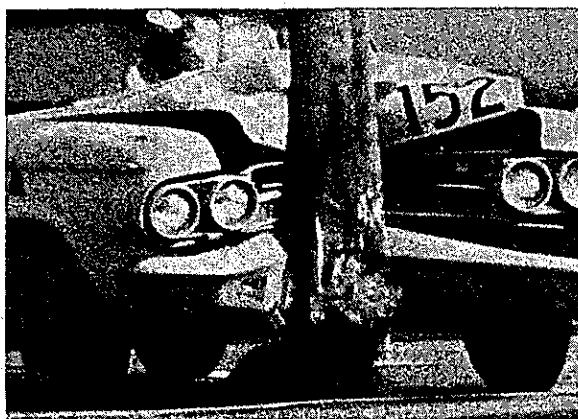
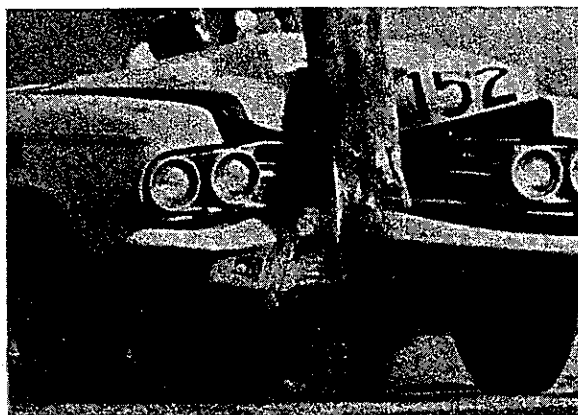
TEST 152 PLATE A

Upon impact the pole broke off 11 in. below ground level and 24 in. above the ground. The upper 15 ft. section of pole tore loose from both sign panels, was flipped up and came down on the crash vehicle deforming the roof and shattering the rear window. The four lag bolts, attaching the sign panels to the pole, pulled out of the impacted pole without damaging the sign panels. The panels remained attached to the right support pole and were used in the subsequent test without repairs.

A review of the high speed data film indicated that the pole failure resulted primarily from excessive bending

stresses rather than from the direct shear force of the vehicle impact. See Test 152, Plate A of the Appendix.

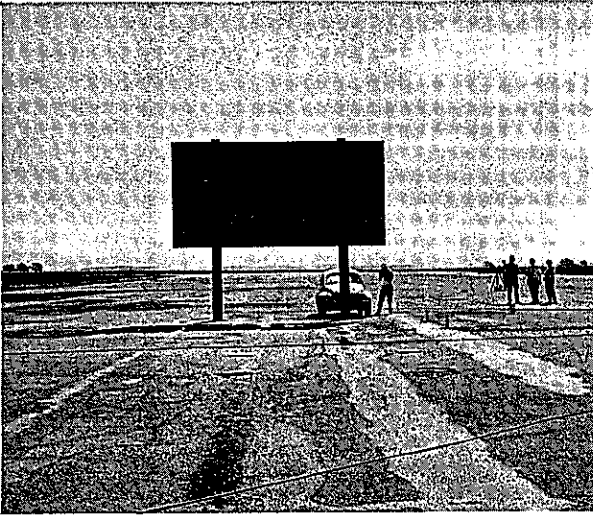
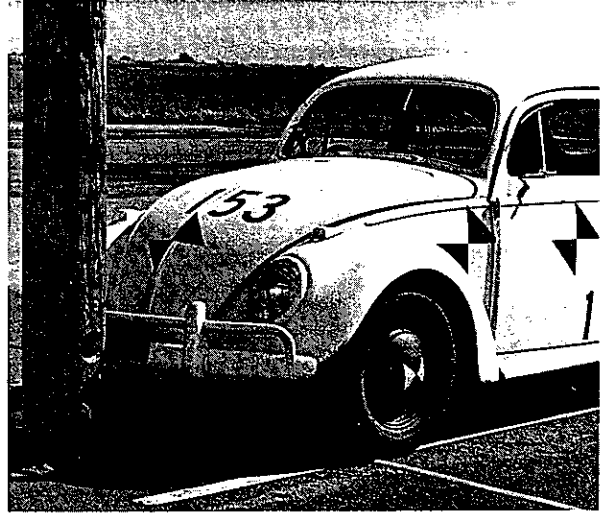
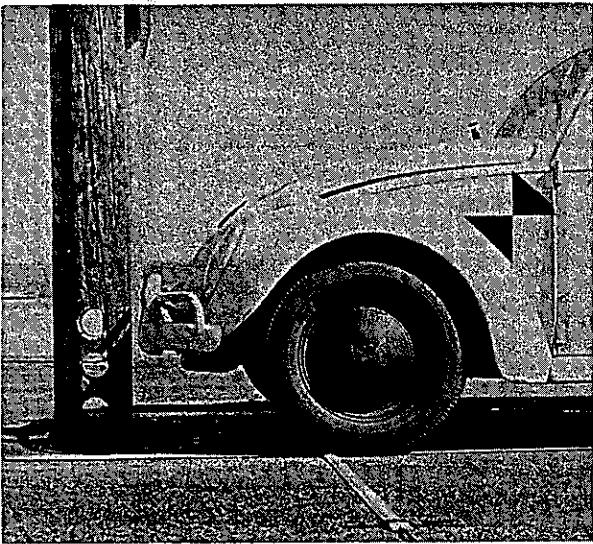
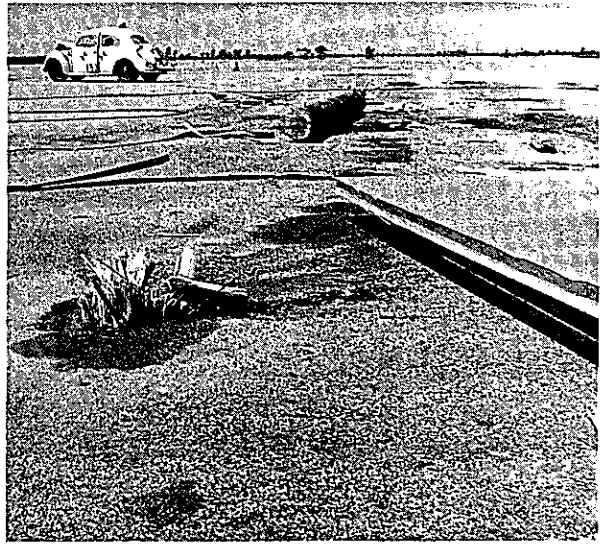
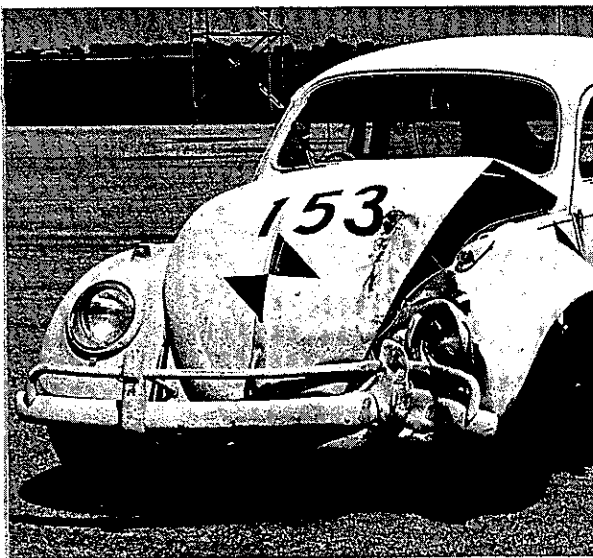
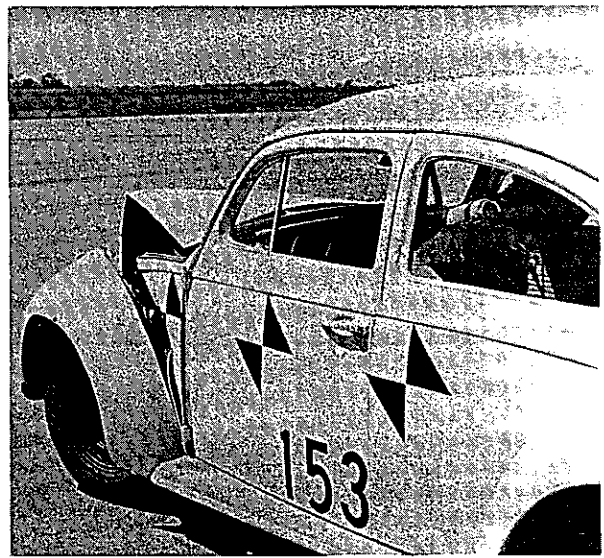
TEST 153 PLATE D

The test vehicle impacted "head-on" into the modified post, at a speed of 39 mph. The vehicle's exit speed was 27 mph. The vehicle was redirected approximately 5 degrees to the left, probably as the result of impact being approximately 1.5 ft. to the left of the vehicle center. The impacted pole fractured at the bottom hole approximately 2 in. above the ground and the section

containing the three holes split in two and was crushed by the force of impact. The remaining 15 ft. of pole was kicked ahead and up, and it tore loose from the sign panels. Had the vehicle not been redirected slightly, it is probable that this section, as it fell, would have struck the vehicle top as in the previous test. The sign panels pulled loose from the other support post and fell to the ground directly below.

The vehicle sustained moderate front end and under-carriage damage with the left front wheel pushed back approximately 6" and the steering column 3". Repair costs were estimated at \$250.
